## Aircraft Induced Lightning

*Improving the predictability for the Mainport Schiphol operation*

Brian Verhoeven  
15-01-2021  
1

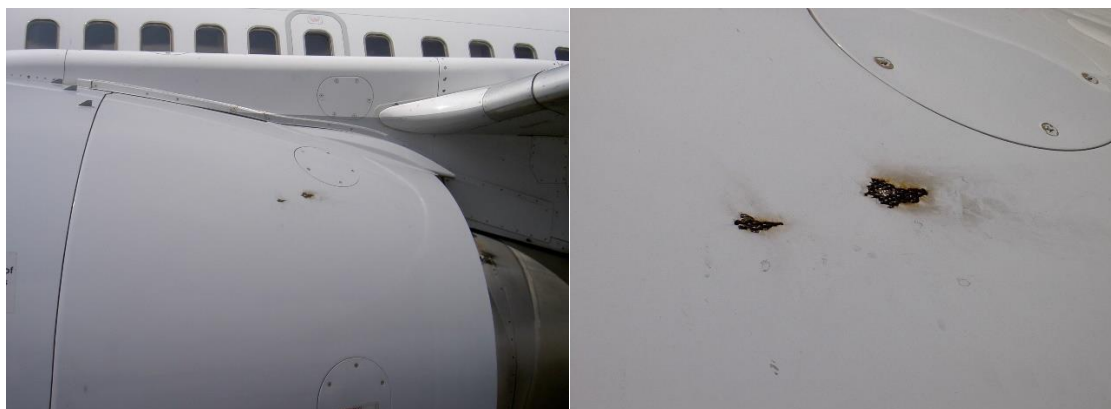
**Figure 7 Two images of damage to the engine of an Airbus A380. The second (right) image is a close up of the first (left) image. Images supplied by an anonymous pilot.**

Figure 7 shows clear burn marks on the engine cowling of the reverse thruster. The damage on this aircraft was significant enough to cause cancellation of two flights, as the reverse thruster engine cowling was unable to extend anymore.

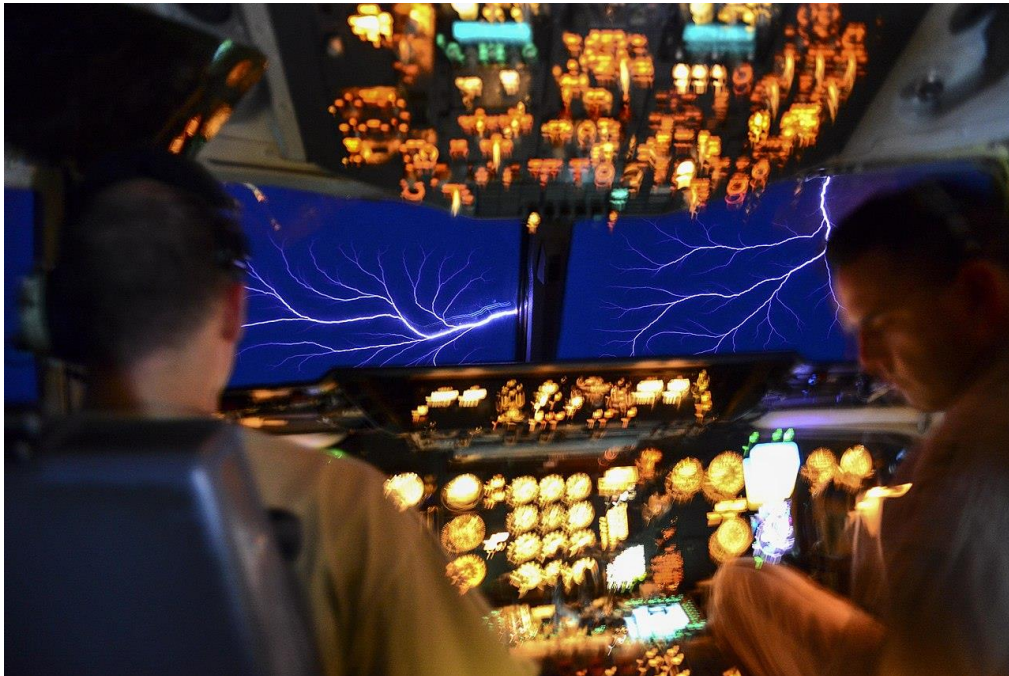
**Figure 13 Saint Elmo's fire on the windshield of a KC-10 aircraft. Image courtesy: Wikipedia / Senior Airman Brian Kelly.**

Saint Elmo’s fire, or corona discharges on the aircraft, has been discussed as an indication of the aircraft becoming electrically charged in scientific literature as well (e.g. Laroche et al., 2012; Uman & Rakov, 2013; Morgan et al., 2012).

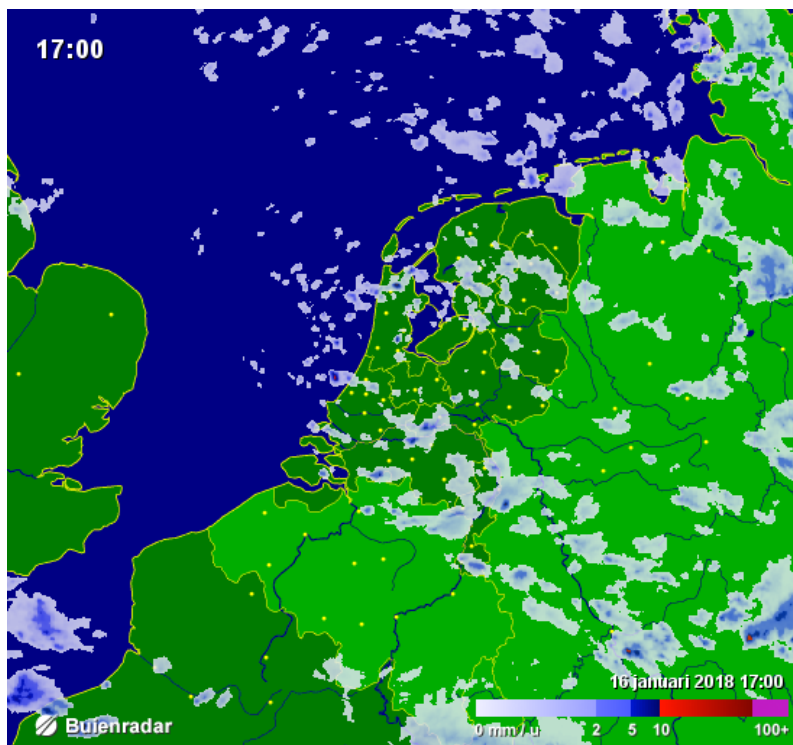
**Figure B2** Radar image for 16th of January 2018. Some cells, also nearby Schiphol Airport, are stronger with dark blue or red colours.

Situations like these are recognizable as days where showers arrive from the west, northwest or north. On the weather radar, many showers are visible. Figure B2 is an example of how such a weather radar would look like. Most cells are relatively weak, but some cells are visibly stronger. Especially these stronger cells are capable of producing AIL. Showers in fall or winter also have the tendency to strengthen just west of the coast, which is very typical for The Netherlands. This is mainly a result of both high seawater temperatures and the effect of stronger friction by the earth's surface, which forces air to move vertically (upward), strengthening the showers.

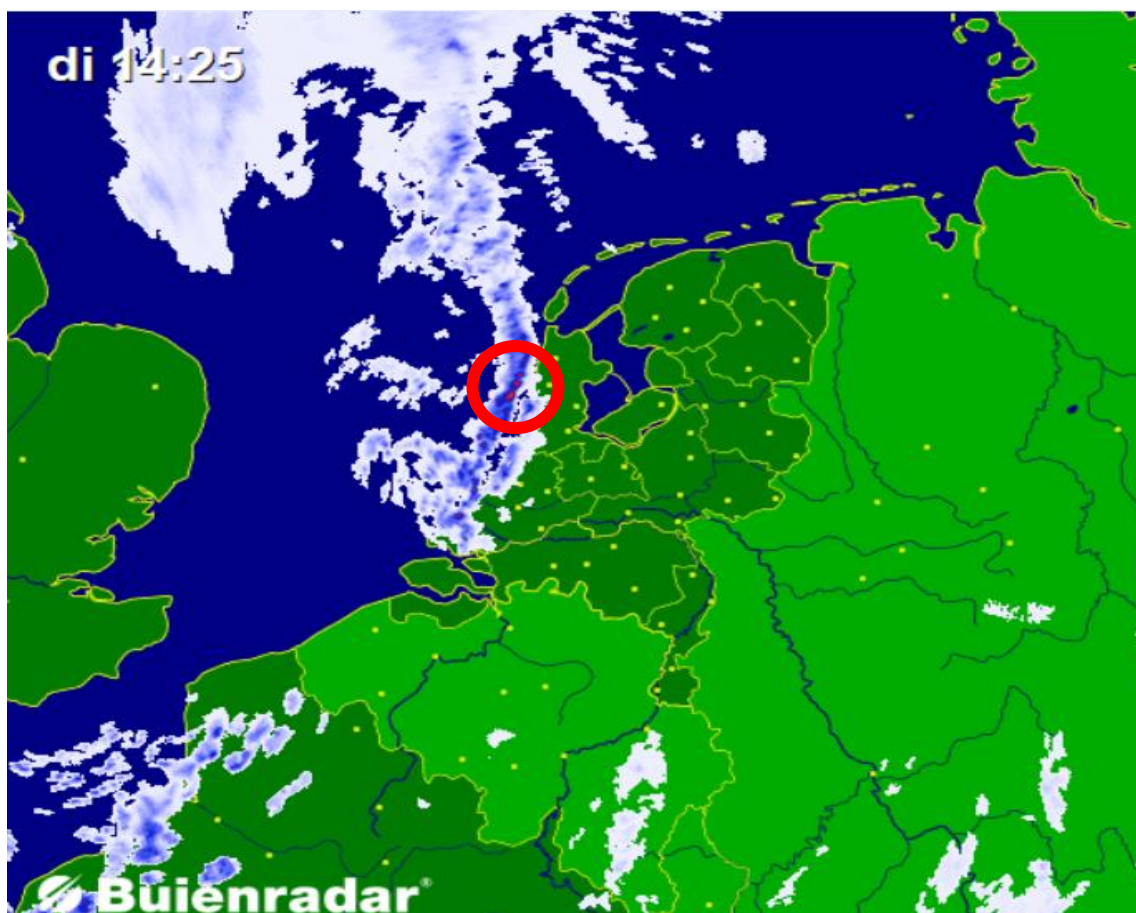
Figure B6 Screenshot of the radar, close to the moment of the AIL case. Note the red colours, indicating the presence of the embedded CB's (withing the red circle). Source: Buienradar.
